SURVEY AND RESEARCH OF 'NEW DISPATCH'

This study was identified by the Nautical Archaeology Society (NAS) as part of the NAS Part 2 Field School at Purton, Gloucestershire in February 2004. It details the survey and research work for the 'New Dispatch' carried out by Keith Peake and Will Tabner to meet the requirements of their NAS Part 2 certification.

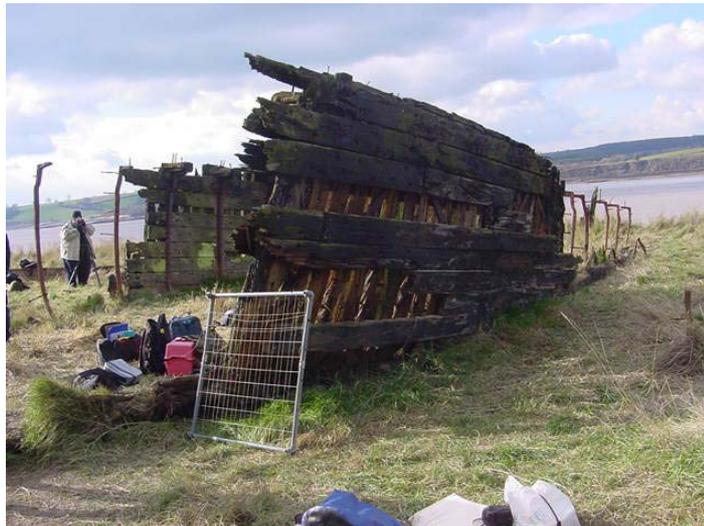
Figure 5 - Wreck Remains of New Dispatch

The visible remains of the New Dispatch consisted of partially intact sections of the port and starboard hulls and stumped remnants of the bow and stern sections, with the bow slightly higher than the stern, and the whole boat nearly perpendicular to the bank.

A large section of the starboard hull was still intact amidships, although showing some fire damage on the outside. Some internal iron frames and diagonal bracing straps were visible, and some knee frames still had the hull trimming device in place. Some of the keel was showing at the bow end of the vessel.

(Photograph by Ian Cundy, MADU website, purton-153.jpg, 29/2/4, looking west towards the river with the port hull in the foreground)

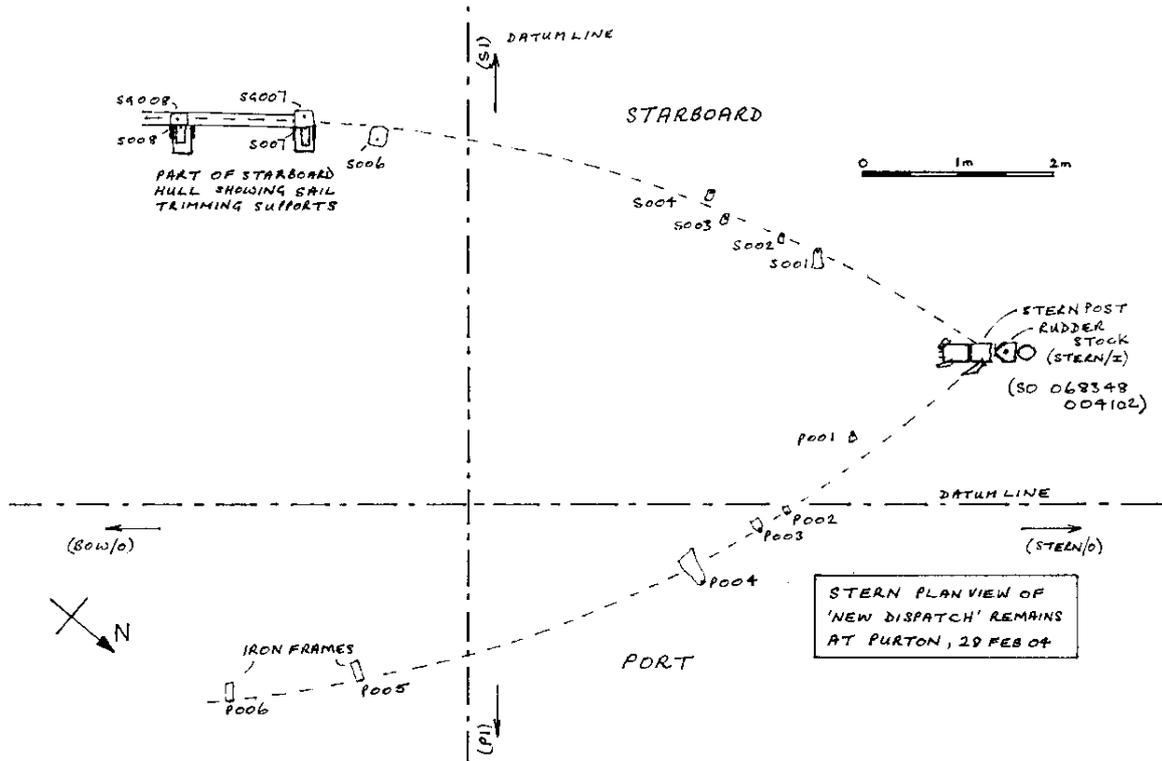
Figure 6 - Measured Plan View of New Dispatch Stern Remains

The visible stern section consisted of the remains of the stern post and rudder stock, and a few futtock stump remains in the grass. On the port side, the stern end of a side timber or deadwood is showing out of the ground and appears to have straightened and is no longer in contact with the stern post. The groove in the stern post (Figure 8) where this would have fitted is weather worn but still clearly visible and shows a gentle curved back to the boat.

Four bolts projected from the inner stern post about 10-15 cm into the wreck. None of the other iron work, for instance pintles and gudgeons remained, although several bolt holes were visible.

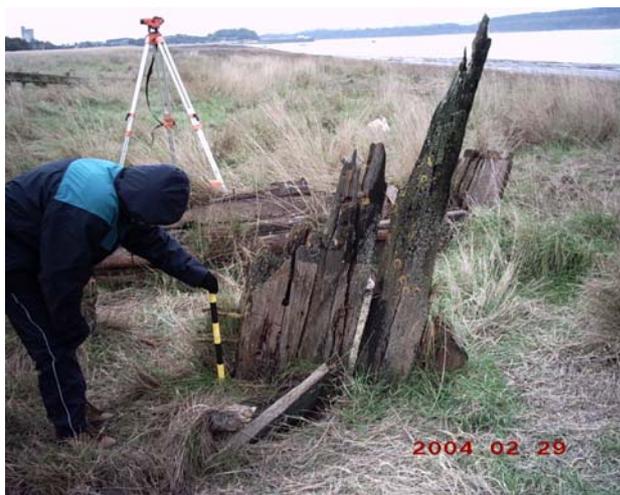
Figure 7 - Rudder Section Remains - Port View
(Photograph by Will Tabner, pict0026.jpg, 29/2/4,
scale 50x10 cm)

The rudder stock could be confirmed because the bevels against the stern post to allow its lateral movement were still visible (Figure 8). Also visible were the ends of the inner stern post and the rudder main piece.

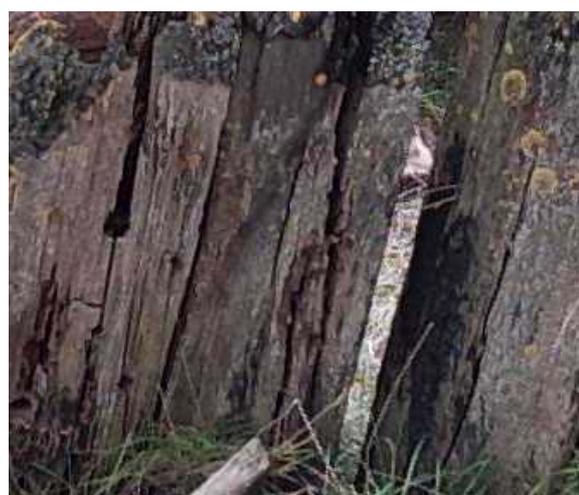
Figure 8 - Expanded view of Figure 7
showing the groove in the stern post and
the bevelled edge of the rudder stock

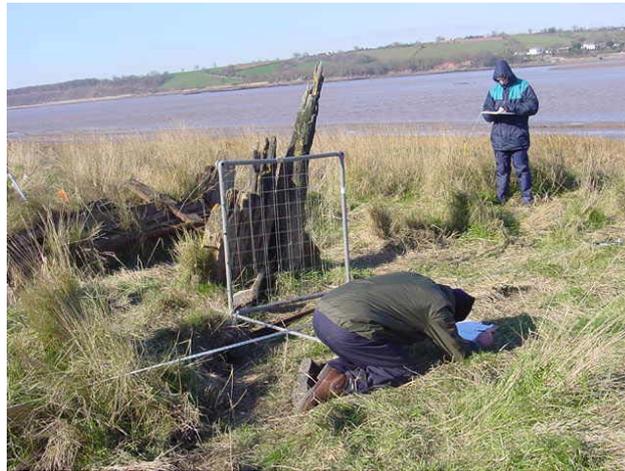
Figure 10 - Rudder Section Survey using a Planning Frame
(Photograph by Ian Cundy, MADU website, purton-153.jpg, 29/2/4)

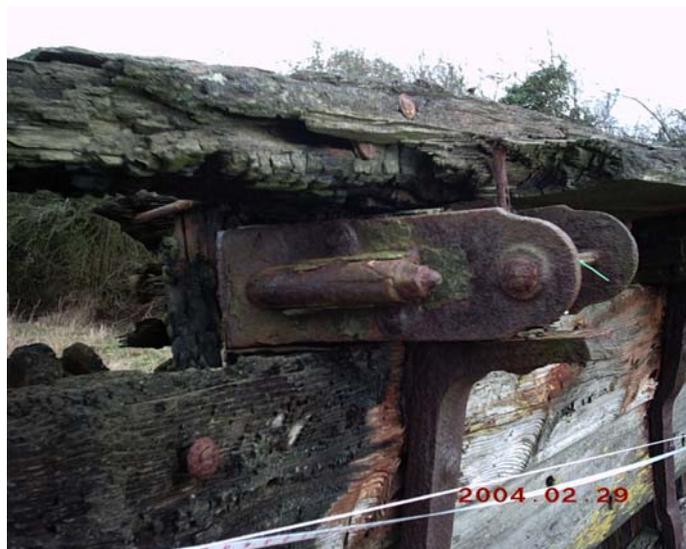
Figure 11 - One Section of the Hull Trimming Gear - Starboard Side

(Photograph by Will Tabner, pict0034.jpg, 29/2/4)
